# **Inspection Report**

## Property Address: 123 Sunbelt Rd Katy TX 77493

**Sunbelt Inspections**

## PROPERTY INSPECTION REPORT FORM

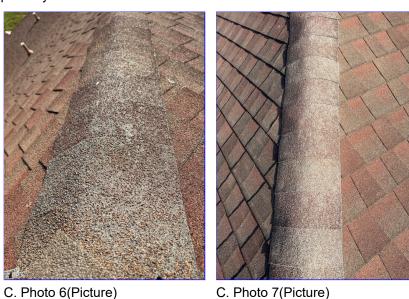
(4) Excessive granules coming off of shingles. This is usually from age, inadequate attic ventilation or possibly a manufacturer defect.

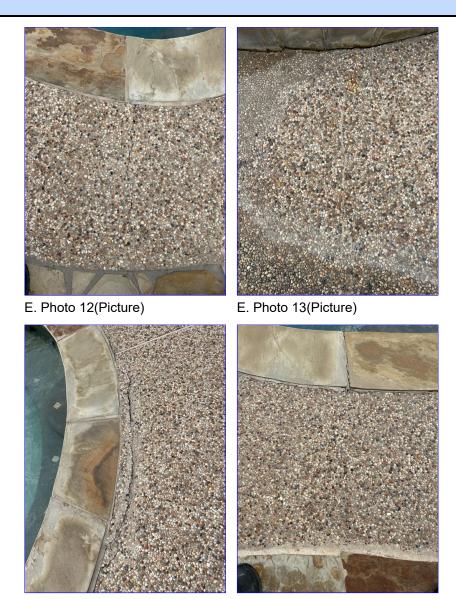
- E. Photo 14(Picture)
- E. Photo 15(Picture)

(4) Several flatwork concrete cracks were observed around the pool.
